10-Year Performance Review of Fiber-Reinforced, Porous Friction Course at Jackson Hole Airport

Submitted to:
FORTA Corporation

July 2, 2019

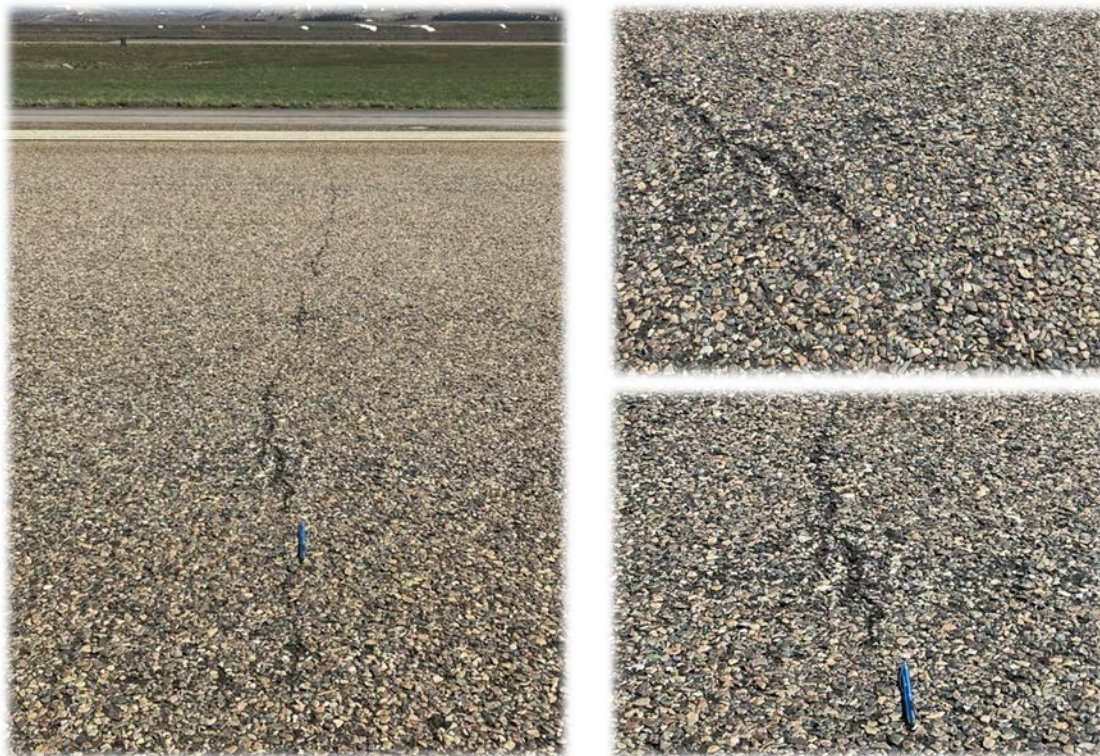
After 10 years of service the FR-PFC visually appeared in good condition with a few minor distresses identified. Around 10 low-severity transverse cracks were noted along the entire length of runway, in an uneven spacing pattern. This is an indication that the asphalt concrete structure, including FR-PFC continues to provide excellent resistance to cracking in an environment with extreme temperature changes that generally facilitates thermal cracking. Figure 4 provides an example of the observed transverse cracks. Longitudinal cracks were observed in some paving lane joints.

Figure 4. Low severity transverse cracking.

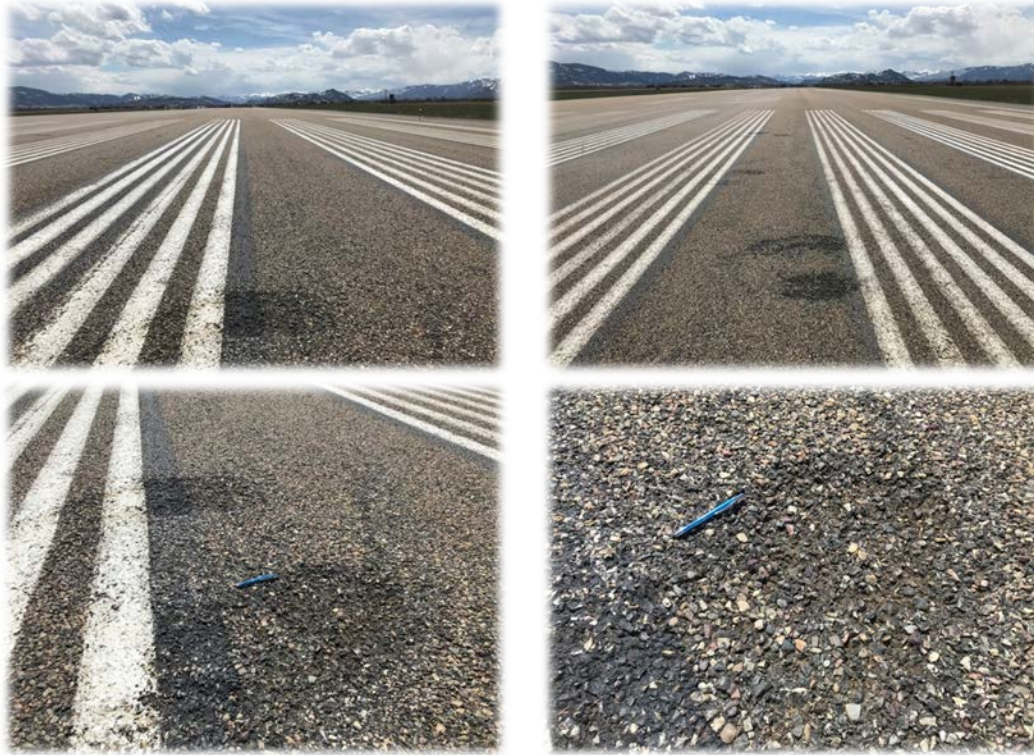
Around 12 small areas (1-2 ft² each) of severe FR-PFC surface material loss were observed near the runway thresholds and near intersections with taxiways (Figure 5). When the parallel taxiway is closed for maintenance or construction, aircraft are required to back-taxi along the runway and perform a locked-wheel turn at the thresholds. This distress predominantly occurs when these turning maneuvers take place on very hot summer days but only when the taxiway is closed for rehabilitation.

Figure 5. FR-PFC material loss from locked-wheel aircraft turning maneuvers.

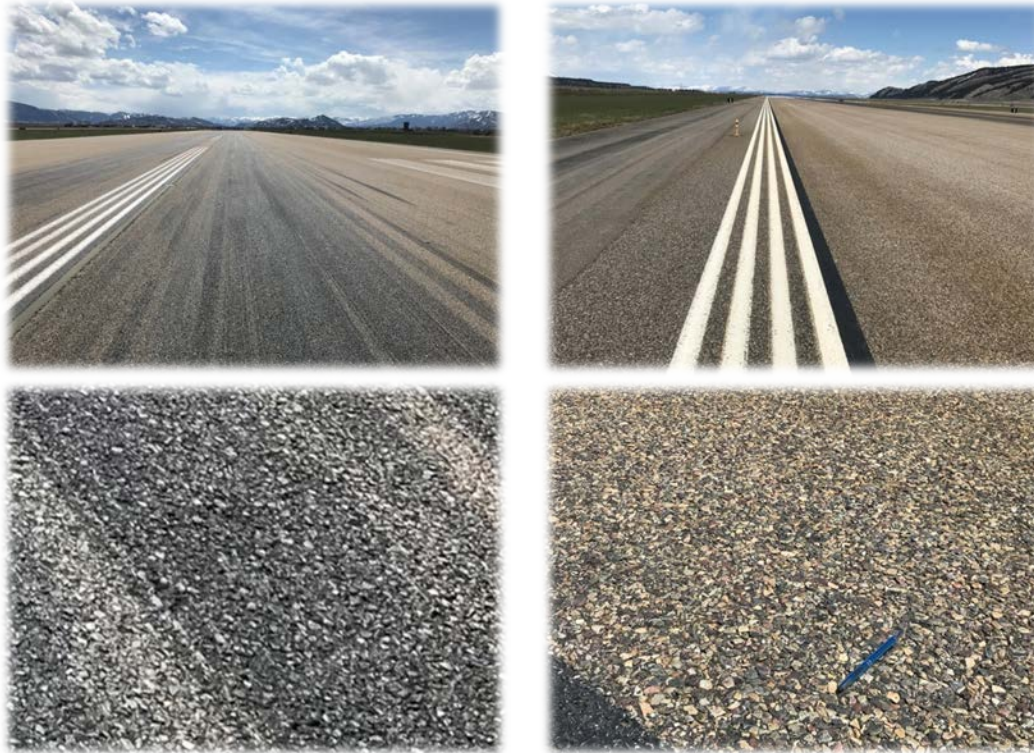
Rubber build-up was observed along the runway centerline and airport personnel indicated that no rubber removal was performed over the 10-year period. Figure 6 provides examples of the runway FR-PFC surface with and without rubber build-up. The entire FR-PFC, except for areas with rubber build-up, had an exposed aggregate surface shown in Figure 7. The original asphalt cement films were worn away, leaving bare aggregate. In general, the FR-PFC exhibited good coarse aggregate retention in the middle-third of the runway width and moderate coarse aggregate retention along the outer thirds of the runway width (see Figure 8). Moderate aggregate polishing was evident in the middle-third of the runway width. Longitudinal paving joints had signs of deterioration with loss of coarse aggregate and intermittent cracking (see Figure 9).

Figure 6. Example of centerline surface with rubber build-up (top-left image) edge surface (top-right image) and associated close-up of surfaces (bottom images).

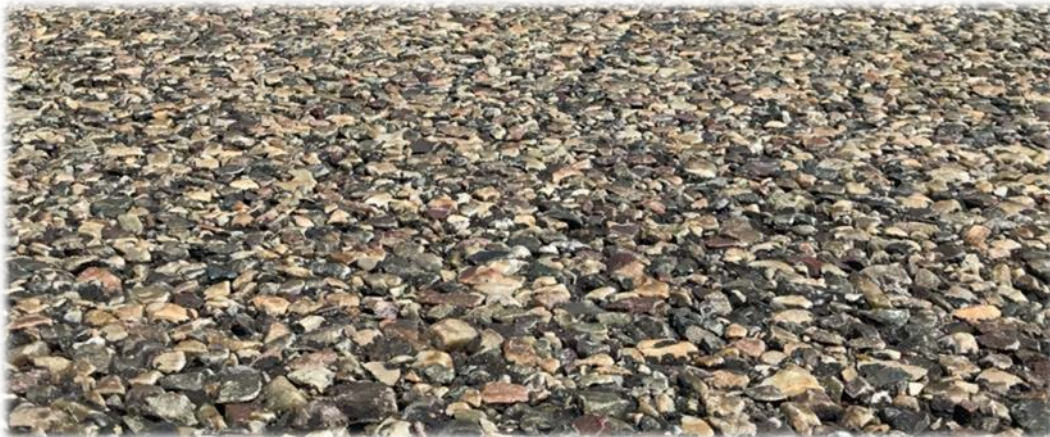
Figure 7. Close-up of typical exposed aggregate (1/2-inch) surface observed on the runway.

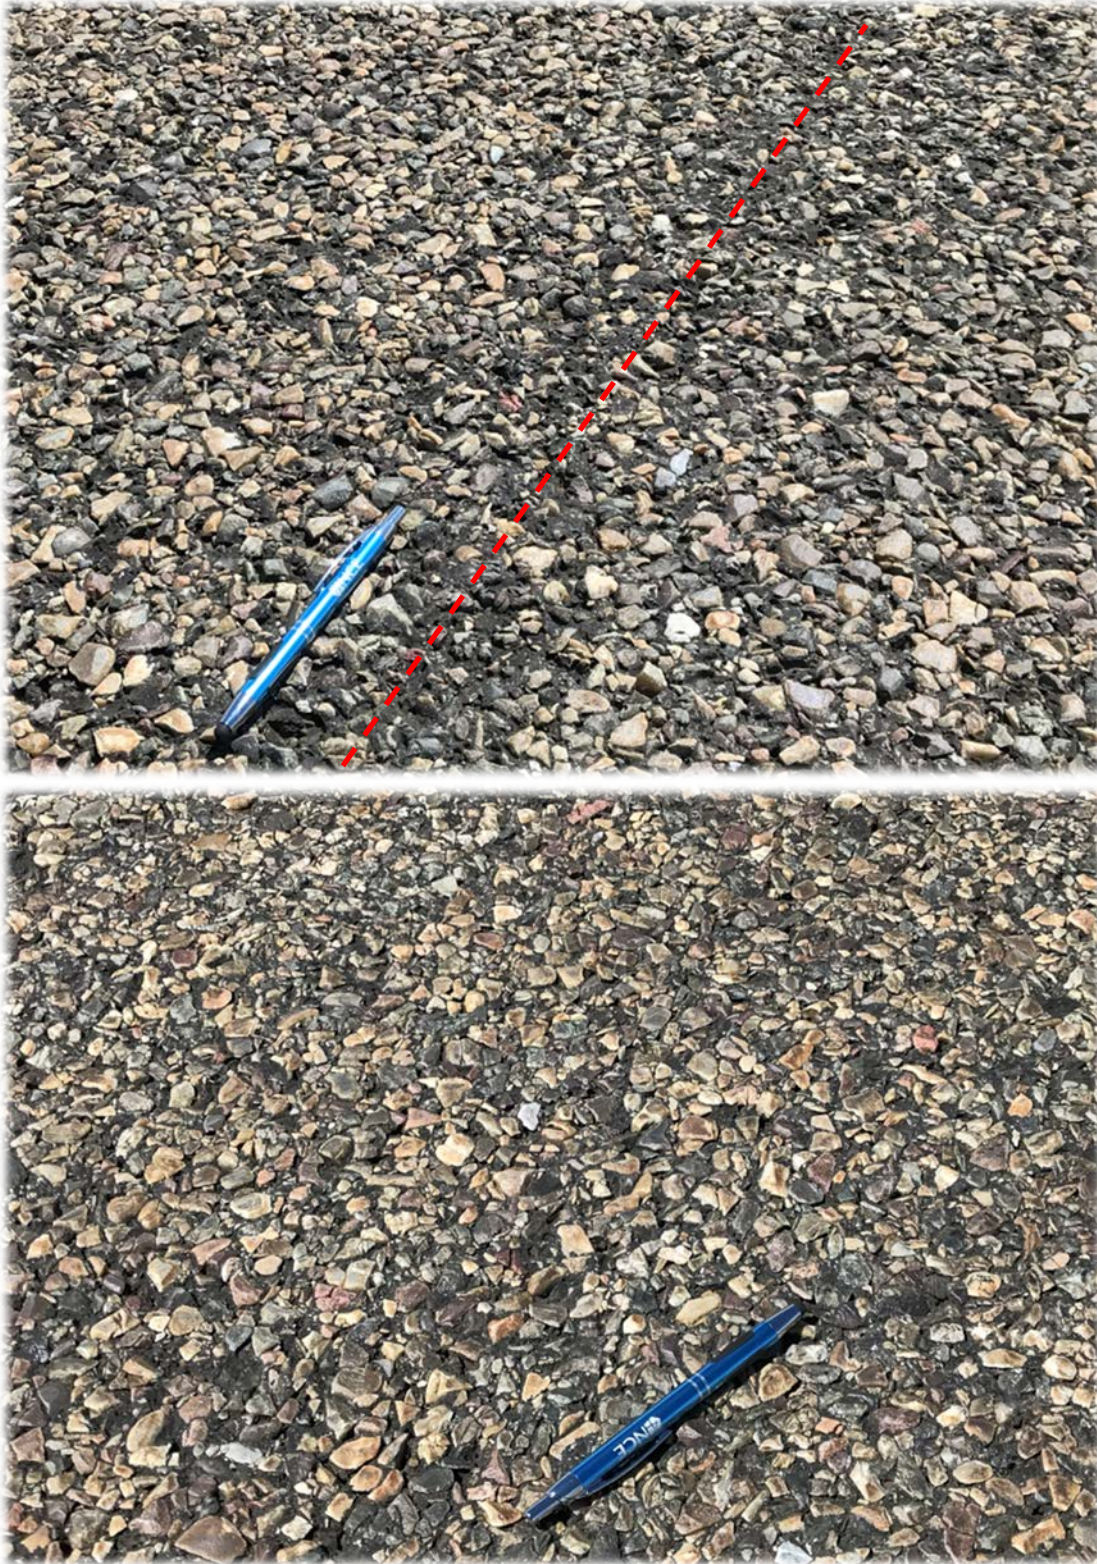
Figure 8. Top image: moderate coarse aggregate retention on outer thirds of the runway width and a deteriorating longitudinal paving joint (red dashed line). Bottom image: good coarse aggregate retention in the middle-third of the runway width.

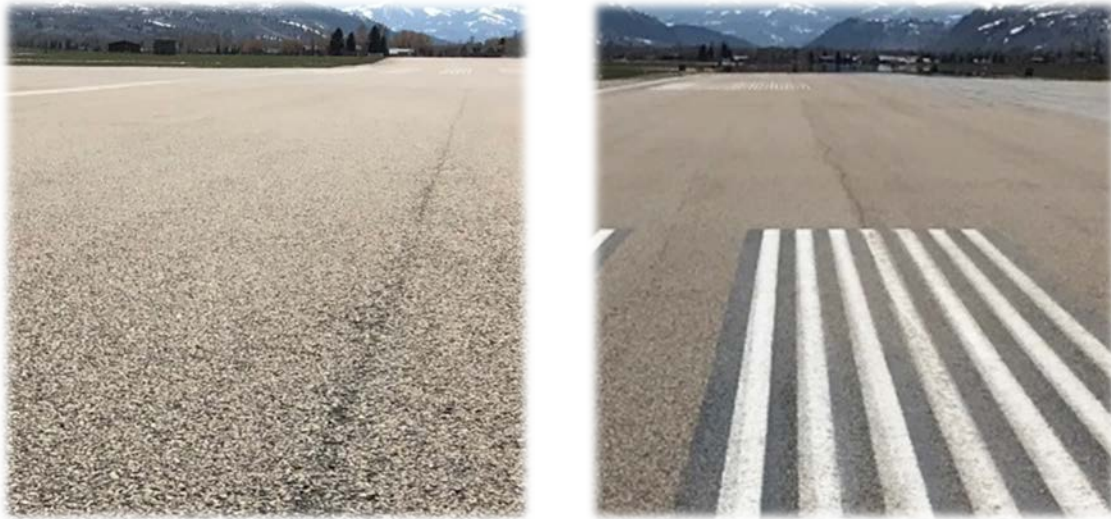
Figure 9. Example of deterioration at longitudinal paving joints.
